TECHNICAL REPORT SL-84-10

# HOW TO AVOID DEFICIENCIES IN PORTLAND-CEMENT PLASTER CONSTRUCTION

June 1984

Final Report

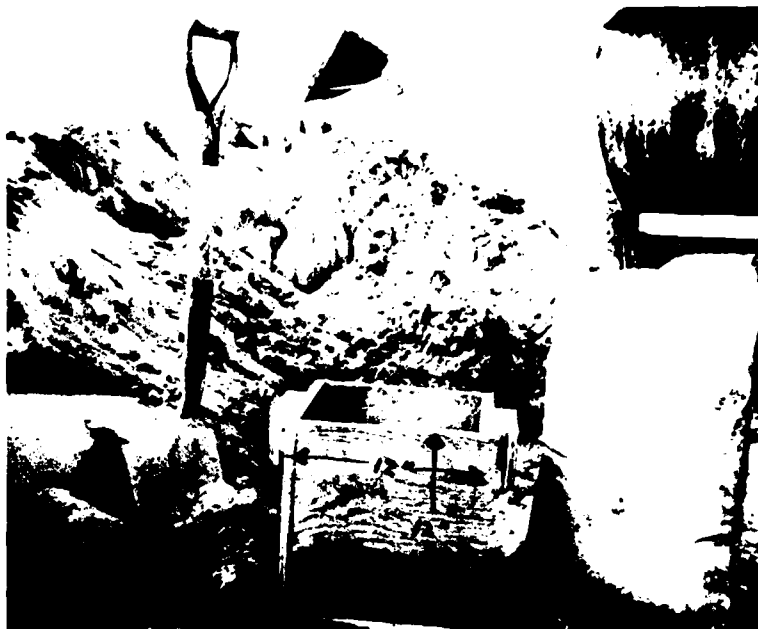
Improper batching  
of plaster.

Inspection of mixing site may reveal haphazard procedures that do not conform to specifications.

Lack of quality control at mixer leads to variations in the quality of the plaster.

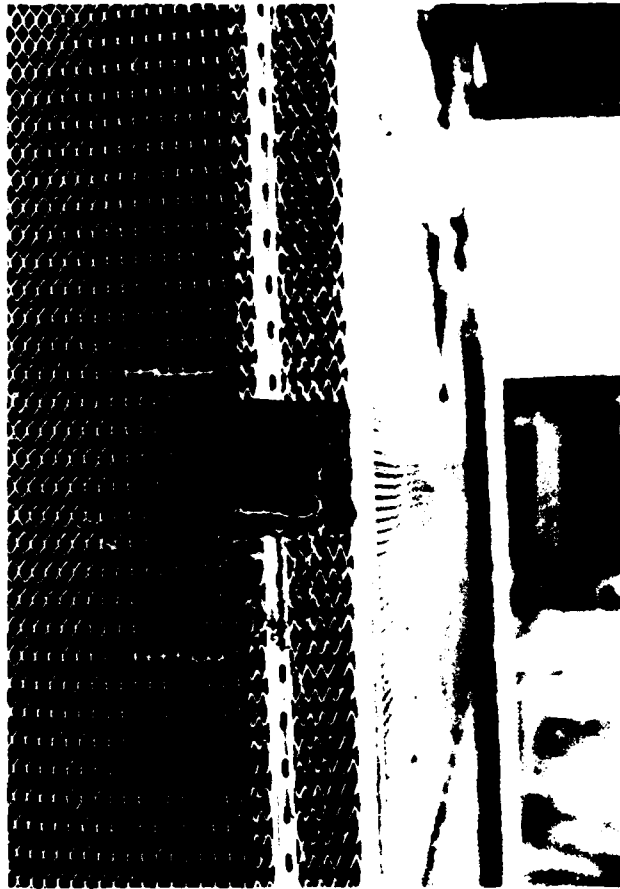
Lath panel clearly reveals vertical rather than horizontal placement.

Improper installation can cause cracking.

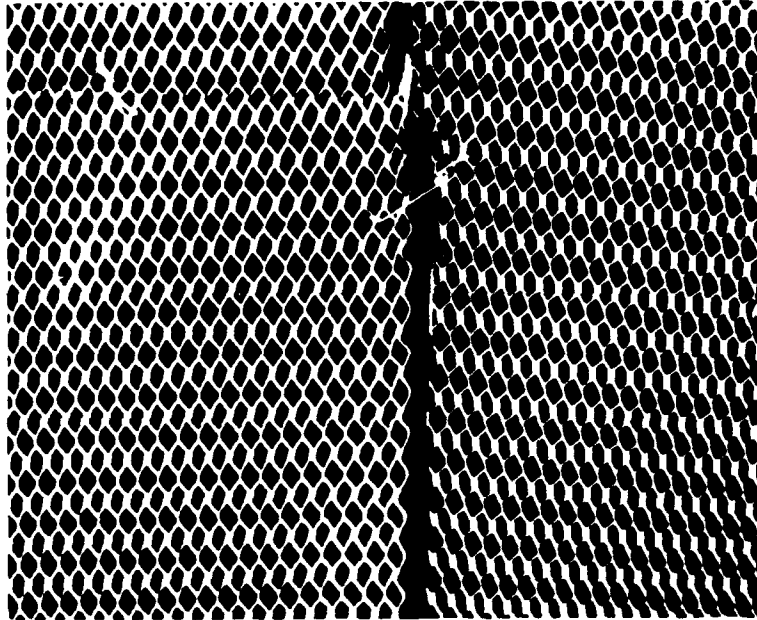
Paper exposed due  
to failure to split paper-  
backed lath at lap joint.

Improper application will cause cracking.

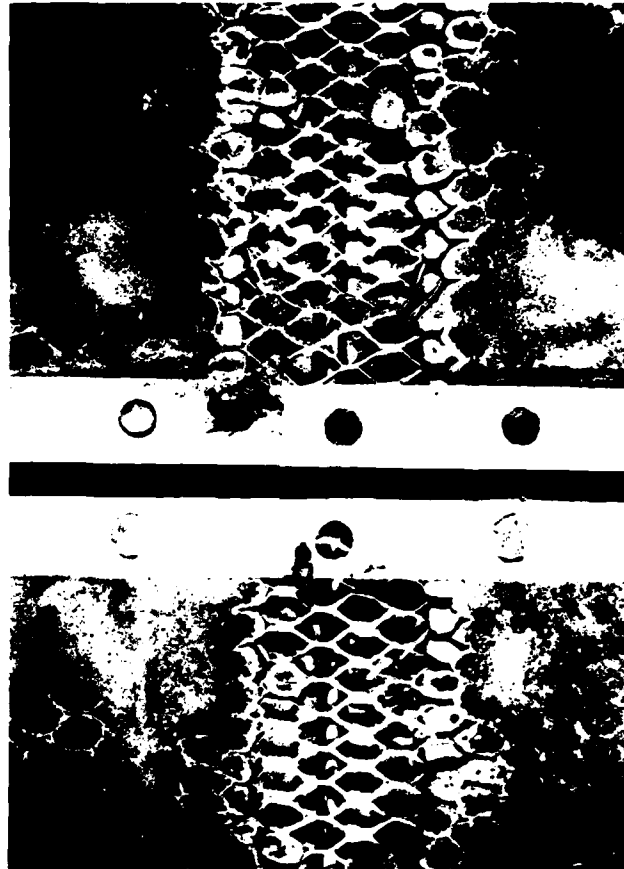
Joint reveals underlying wire mesh lath behind vertical control joint.

Improper installation. If the lath is not discontinued, the joint will not function and can result in cracking.

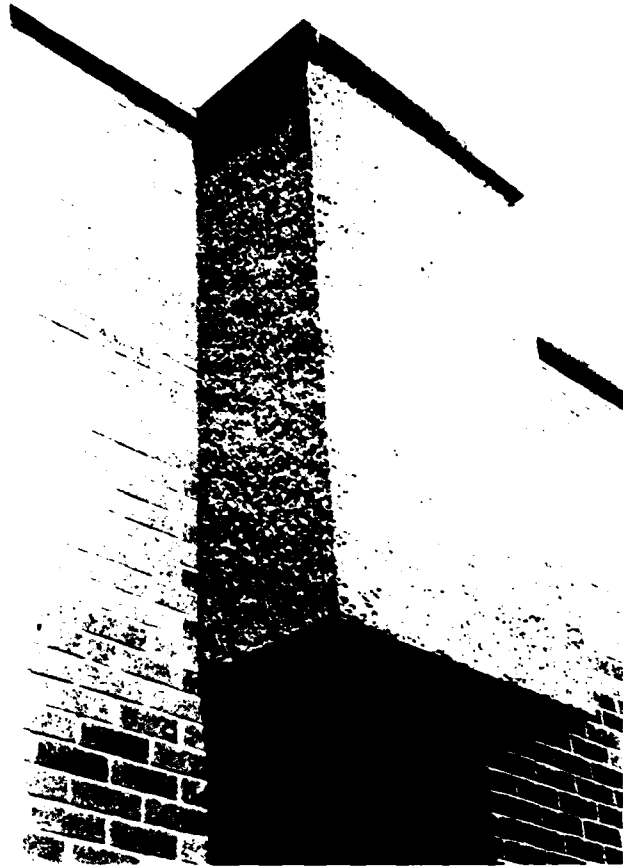
An uneven depth of setting plaster and a nonuniform application of aggregate.

The applicator was inexperienced or was given improper guidance.
